# Manhole Inspection Summary

Manhole # S13GG2010MH

Insp Date: **6/29/06 10:07 AM**

**Location** Address: **2122 WESTERN RUN DR** Cross Street: **EASTCLIFF DR**

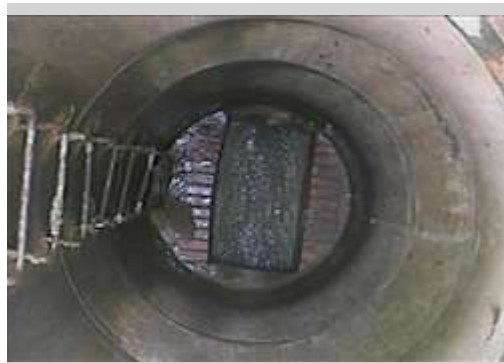
Top View

Bench debris.

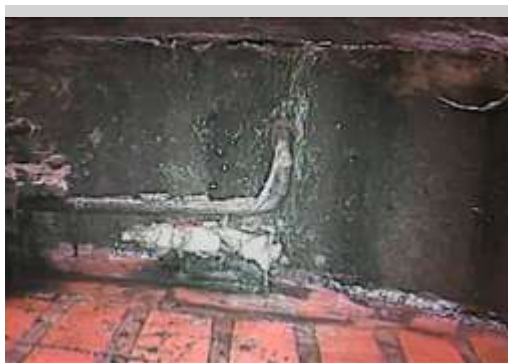
Defect

Comments **The Barrel has active infiltration.**

**Barrel** Material: **Precast Concrete** ☐ Parged  
Shape: **Circular** Diameter: **48** (in.) Length: (in.)  
Condition: ☒ Sound ☐ Cracked ☐ Root Intrusion ☐ Loose Brick ☐ Deteriorated  
Infiltration: ☐ None ☒ **Joint** ☐ Cracks ☐ Mortar ☐ Roots ☐ Wall

Barrel infiltration(Active gusher).

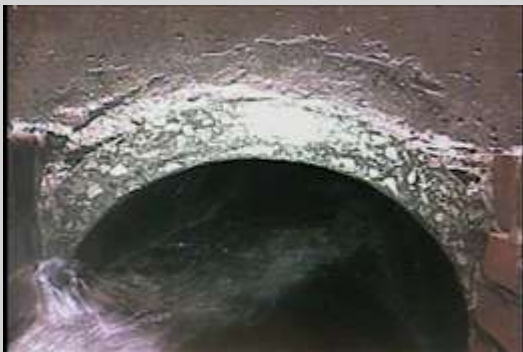
### 21 in. Circular Gravity Sewer Pipe Out @ 12 O'Clock

Infiltration: **None** Pipe Seal Cond: **Cracked**
